SERVICE INSTRUCTION

SI 06-01

SUBJECT: **AD 79-22-04, Alternate Means of Compliance**

MODEL/SERIALS AFFECTED:	AA-5	All
	AA-5A	All
	AA-5B	All
	AG-5B	Not Affected

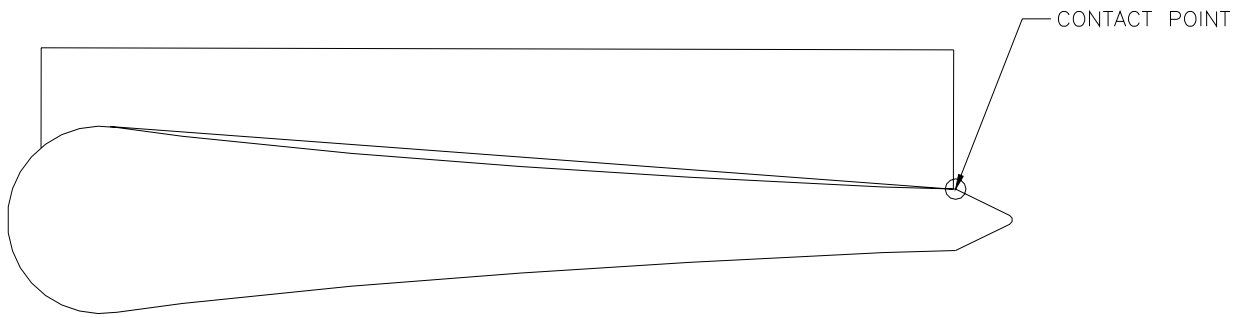
CORRECT CONTOUR
Figure 3

- C. If there is no skin contact with the template other than at the forward and rear aileron spar as shown in Figure 3, the aileron skin contour complies with the intended aileron design criteria. If both ailerons are found to be in contour and Service Bulletin 163 has been complied with, then the aircraft is acceptable and further repetitive inspections of the control system per Airworthiness Directive 79-22-04 are no longer required.
- D. If any aileron skin contacts the template at a point other than the forward and trailing edge spar as shown in Figure 4, the aileron is out of contour. Aircraft with an out of contour aileron must be inspected every 100 hours in service to the requirements described in AD 79-22-04 paragraph (b).
- E. Record compliance with this service instruction in the aircraft log book.

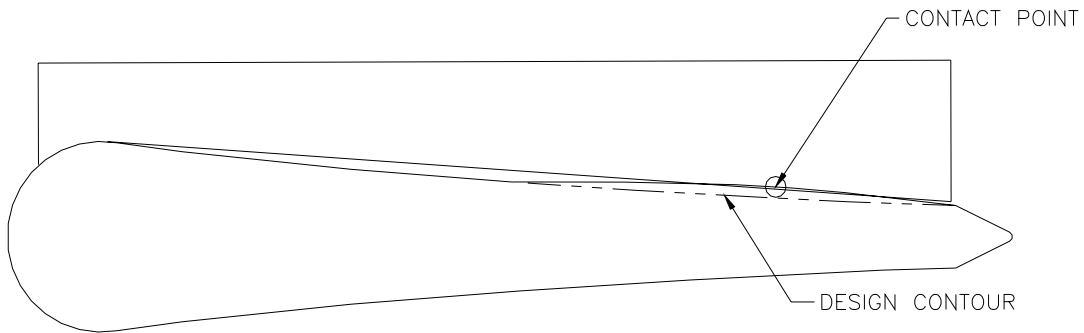
INCORRECT CONTOUR
Figure 4

It has been determined that the primary cause of occasional aileron oscillation on some AA-5 series aircraft is a deviation in the contour of the aileron skin across the aft 1/3 of the aileron chord. By verifying that correctly contoured ailerons are installed, the 100 hour inspections mandated by AD 79-22-04 may be eliminated.

CAUTION: DO NOT ATTEMPT TO ALTER THE SKIN BY DEFORMATION. MINOR CONTOUR DEVIATIONS IN THIS AREA CAN CAUSE MAJOR HANDLING CHANGES.
